# **Investigation of the Causes of Leaks in Natural Gas Pipeline Compression Couplings**

**Washington Gas Company**

**ENVIRON International Corporation**

July 1, 2005

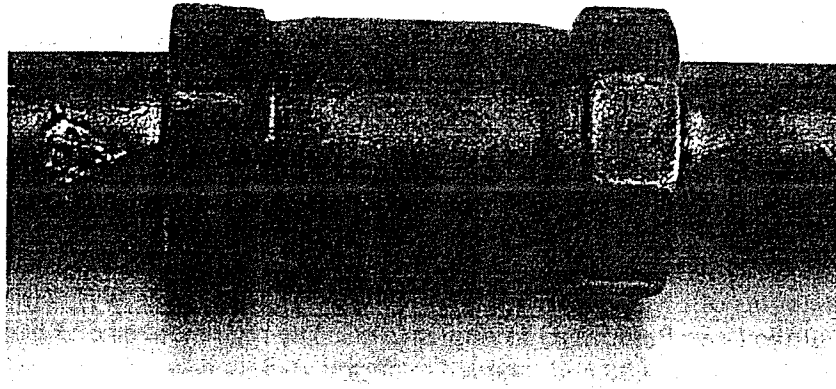
**Figure 1** Two-inch Normac coupling, after removal of tar coating.

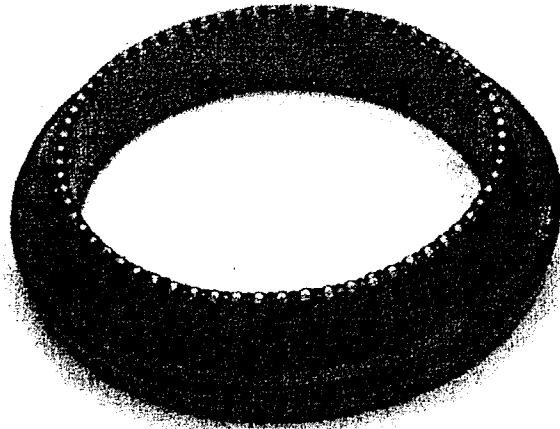
2005-059-26A

**Figure 3** NBR seal from a 2" Normac coupling.

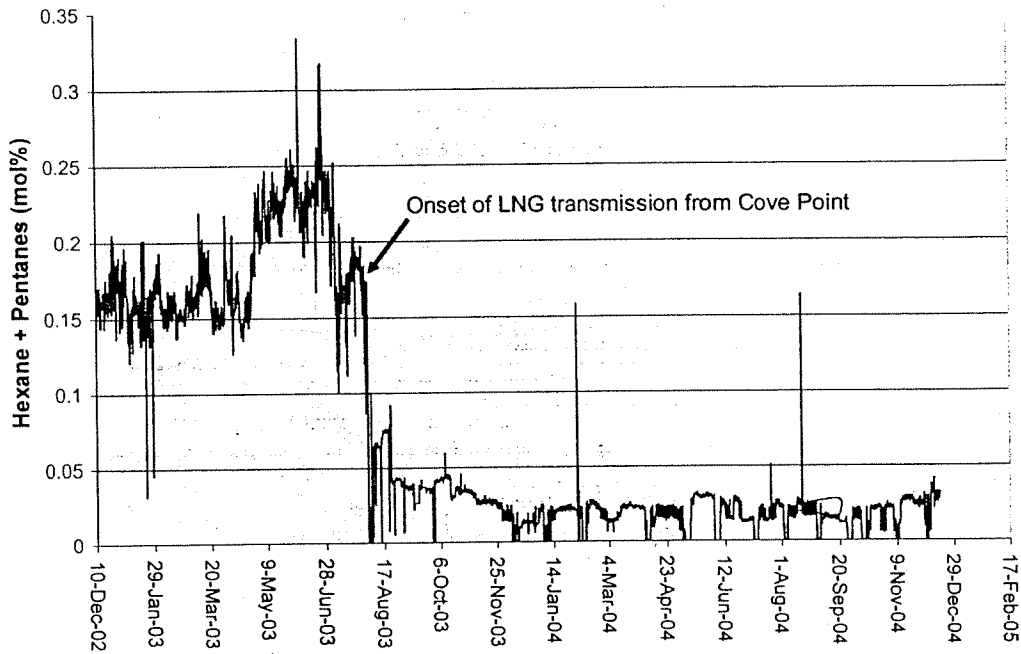
Thus a change from pipeline to LNG gases can result in desorbing of previously adsorbed pentane/hexane and a concomitant shrinking of the elastomer seal. This factor was suggested as the most likely cause of increased leaks in Normac couplings in the LILCO system during the 1992-3 timeframe. This factor was identified as worthy of experimental investigation.

**Figure 4** Change in (C5+C6) concentration at Gardiner Gate after start of LNG transmission in August 2003.

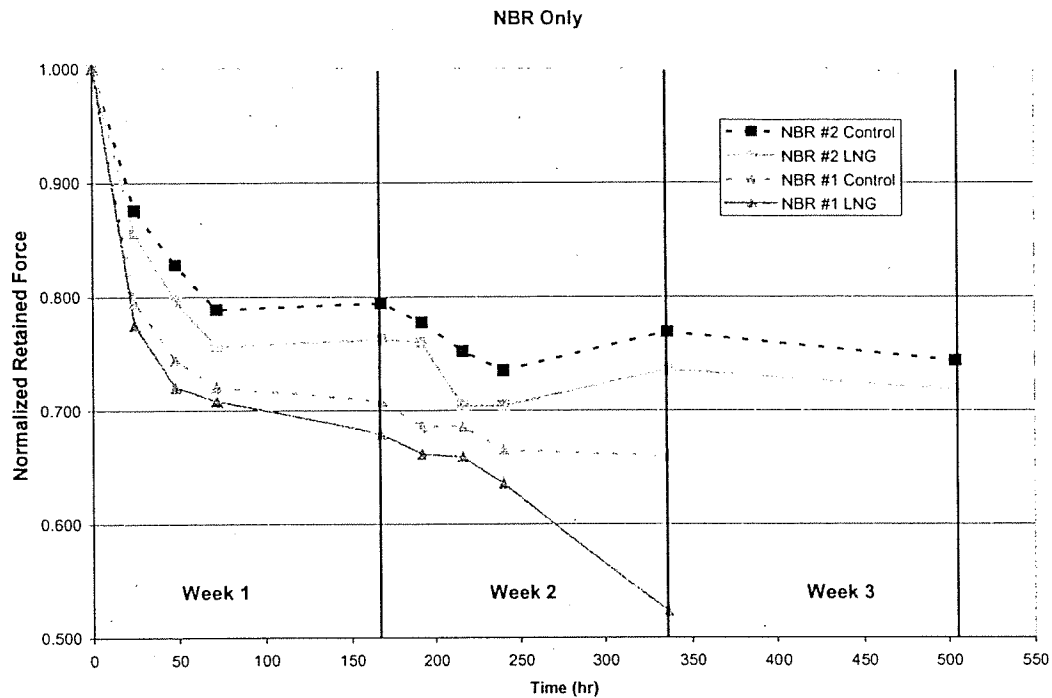
The CSR test results are shown in Figures 6 and 7, below. The data are normalized such that the ratio of the measured counterforce to the initial counterforce is plotted as a function of time.

**Figure 6** Compression stress relaxation results for NBR seals. Test #1 was terminated after 336 hours. Test #2 is continuing.

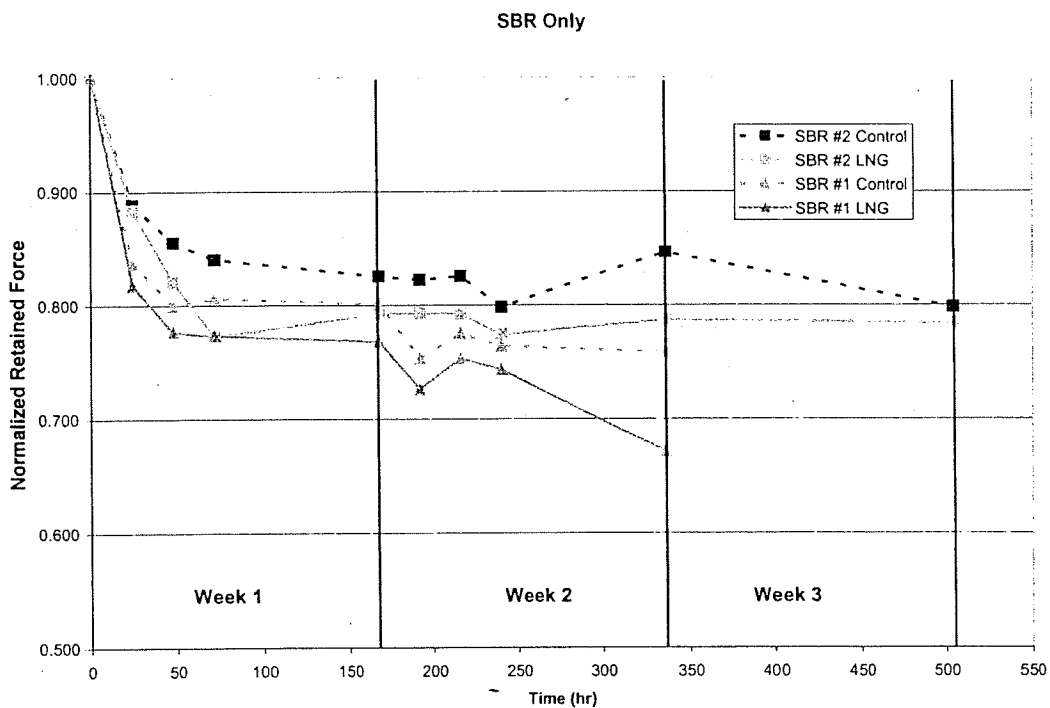
**Figure 7** Compression stress relaxation results for SBR seals. Test #1 was terminated after 336 hours. Test #2 is continuing.

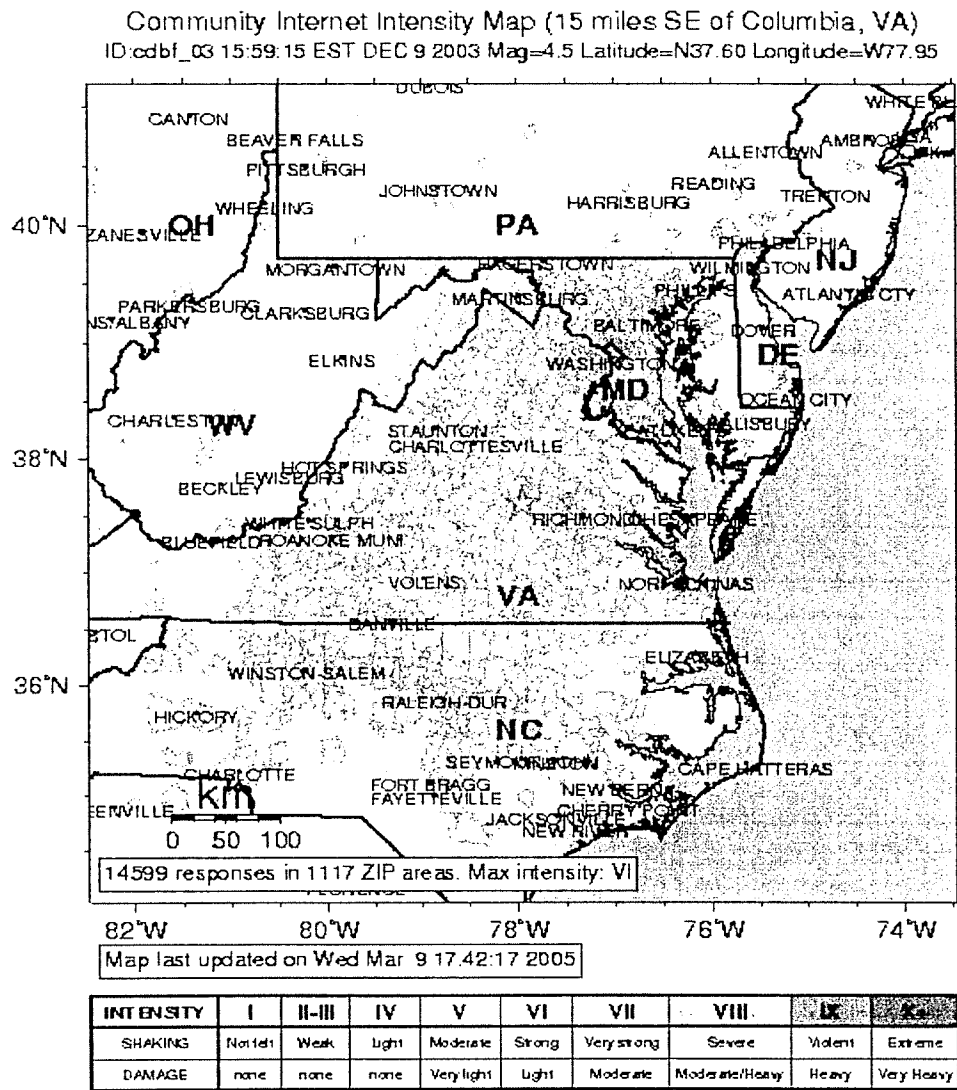
In summary, we believe that the 2003 VA earthquake is unlikely to have resulted in sufficient ground motion to damage the utility pipelines in Prince Georges County for the following reasons:

- Ground subsidence is associated with earthquakes of greater magnitude (>6.3), much greater than the 2003 VA earthquake; and

Figure 8 Reported intensities for December 2003 earthquake.

- Although geologic and hydrogeologic conditions in Prince Georges county suggest the potential for liquefaction, the observed intensity of the 2003 VA earthquake in the vicinity of the Prince Georges county (intensity range: II-IV) is very unlikely to have resulted in ground liquefaction.

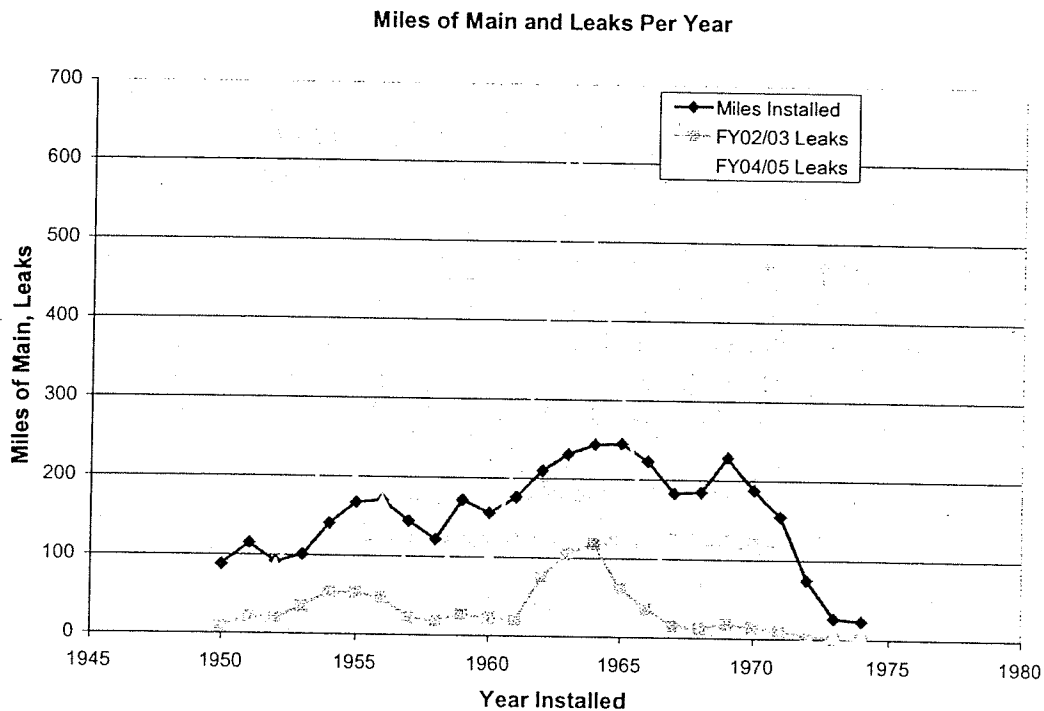
A year-by-year analysis of the leaking couplings from the last two winters shows a clear peak in leaks in those installed in the timeframe 1962-1965, see Figure 9.

**Figure 9** Miles of main installed by year and reported leaks for the last two heating seasons, plotted by year of installation of coupling.

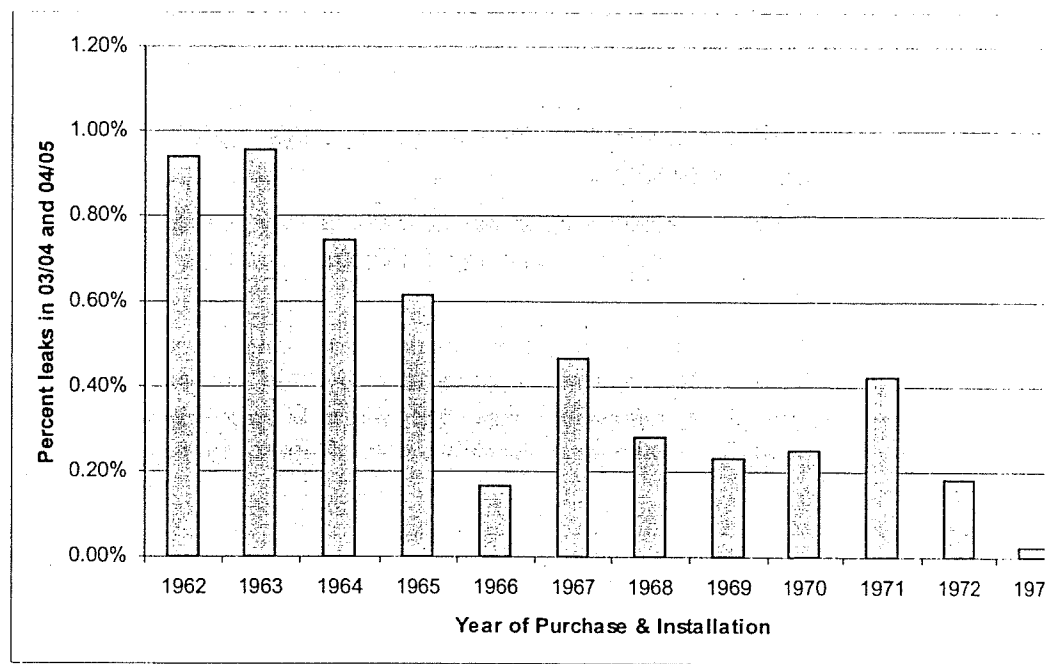
It is worth noting that the installation years which are showing the highest leak rate (1962-1965) correspond to those years in which Normac purchases were approximately equivalent to Dresser purchases. In other years (with the exception of  $\frac{3}{4}$  inch purchases in 1968-1969), Normac couplings were not purchased. We do not have data on the relative leak rates of Normac and Dresser couplings over the last two winters.

**Figure 12** Percentage leak rate (over last two winters) by year of coupling purchase and assumed installation.
